TOCCARE TROUBLESHOOTING

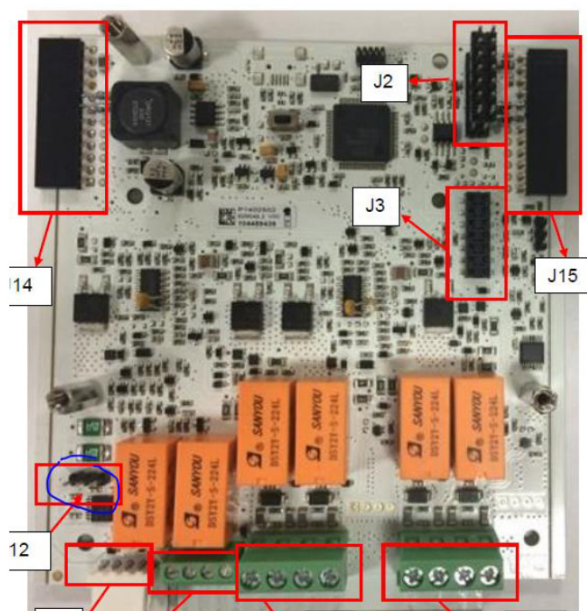
This means that the expansion board is not responding and is either missing, set incorrectly or broken.

This jumper J12 must be placed on the right side, otherwise the board will not work (as it will be stuck on FW update mode).

An expansion board can broke if connected when the panel is turned ON or if it get scratched while trying to fit it on the panel. Always connect boards when the system is OFF and be careful while placing it.

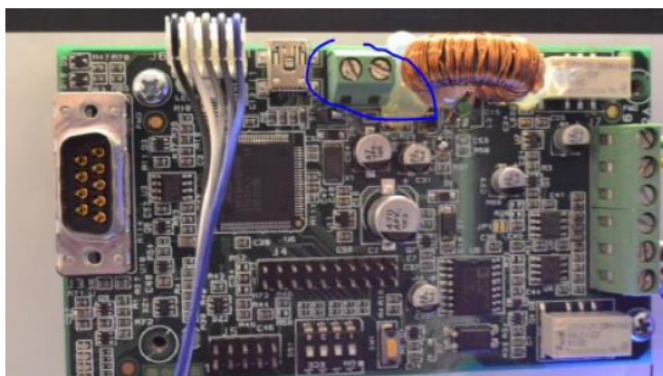
In this case the onering card is either not powered on, disconnected or broken.

Always check if the board is powered on (AUX – GND pins on the panel usually are used to power it) and if its flat cable are connected to the panel correctly.

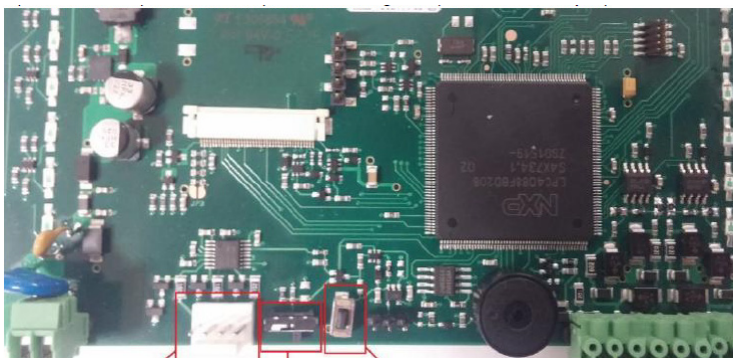
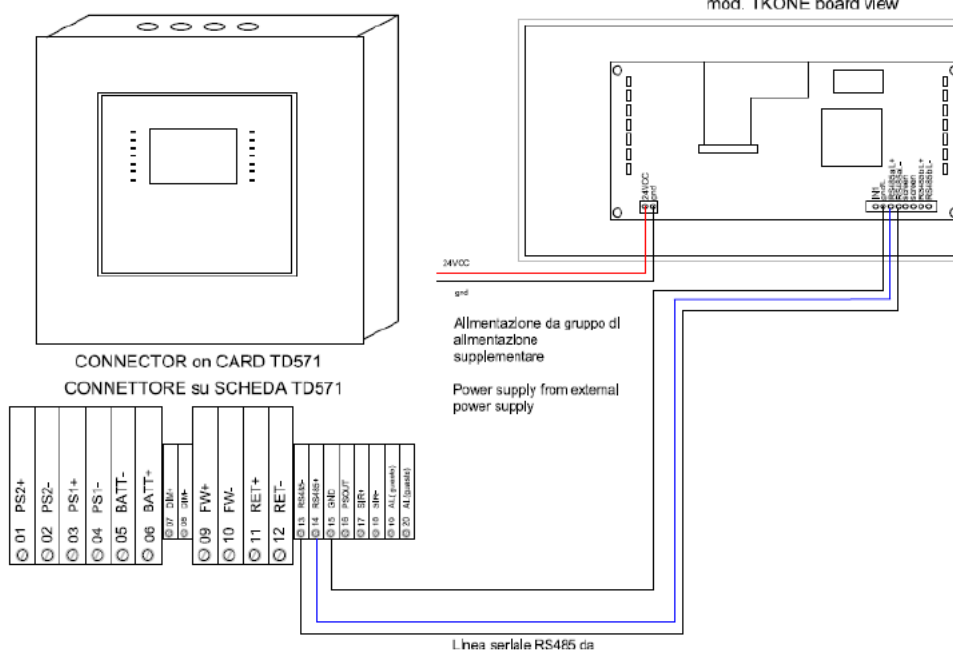
Power supply missing - dipswitch on board placed to the left (must be on the right side, toward the RS485 pins).

In case the Onekbd is powered externally
No common GND (right connection showed here).

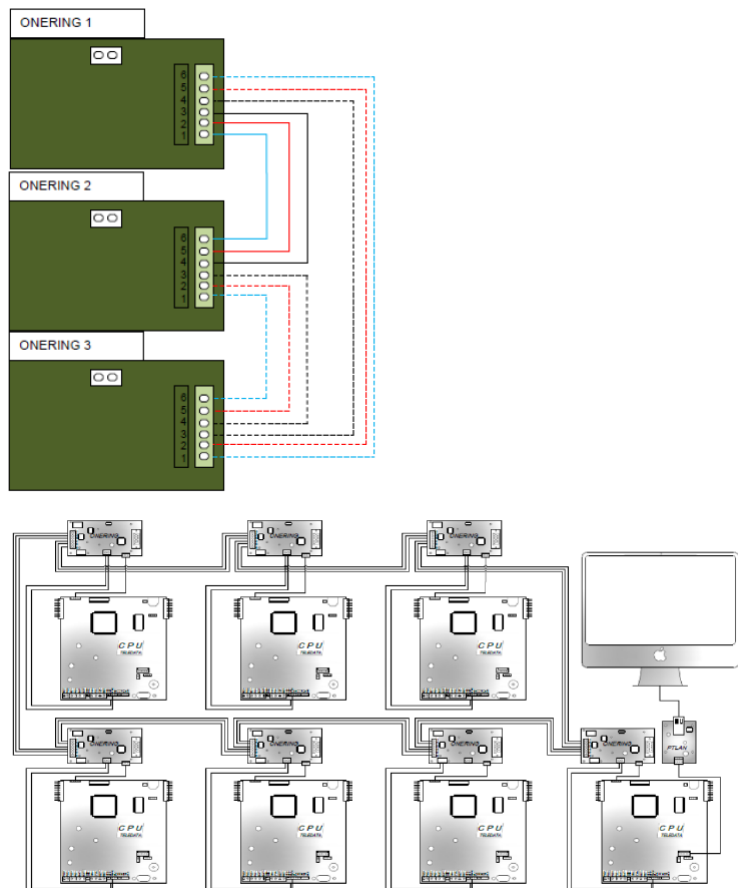
Caused by a cut on the line of the onering connections between the boards, or if the wires are misplaced.

Here some examples of right connections:

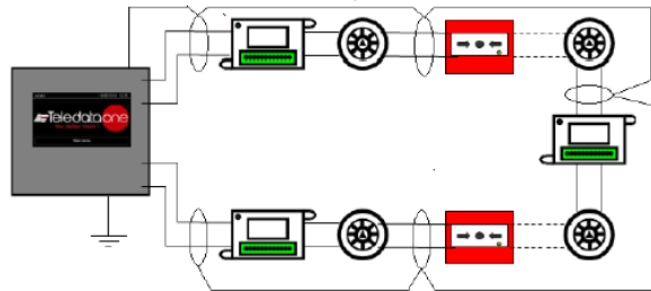
A noise is an external signal that has found its way in the loop, giving problems as mismatch, conflicts, missing devices, high drift or even false alarms.

- with the shielding of the loops cables
- To guarantee the maximum protection to electromagnetic disturbance, a shielded cable with connection of the shield to ground is advised. Shield must be connected in one side of the metallic box of the panel, must be continuous on all cable, must be insulated from conductor and cannot be connected in other places to ground.

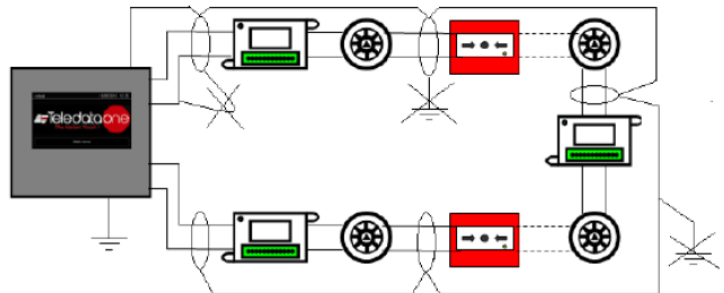
- With a loss of insulation or other connection on ground make the screen protection ineffective, indeed they can amplify the injection of the noise.
